METALS HANDBOOK

VOL. 9
FRACTOGRAPHY AND ATLAS OF FRACTOGRAPHY

8th EDITION

Fractography and Atlas of Fractographs

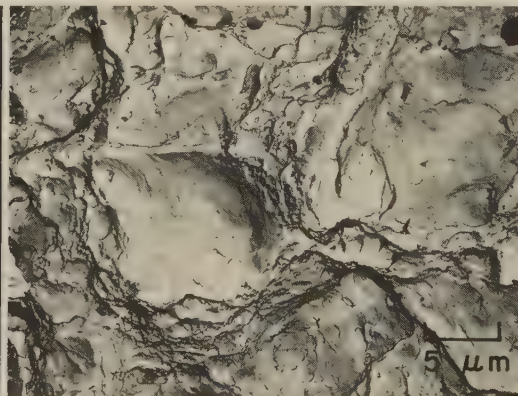
TEM fractograph (p-c replica) 2000×

4994 Surface of a third impact fracture in hydrogen-embrittled 4340 steel, showing intergranular facets. Between the intergranular facets, however, are regions of dimples that were produced by microvoid coalescence.

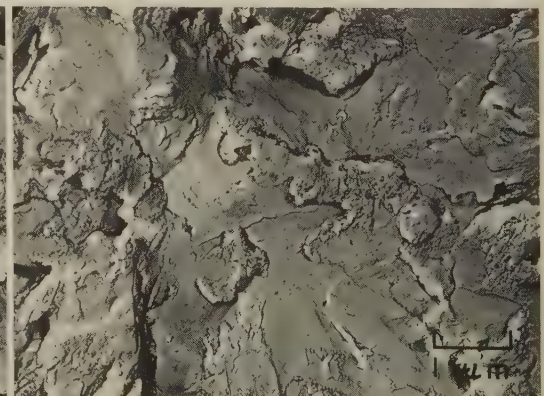
TEM fractograph (p-c replica) 10,000×

4995 Surface of a fourth impact fracture in hydrogen-embrittled 4340 steel, showing the intergranular facets expected of hydrogen cracking plus many areas of transgranular, quasicleavage facets. See also 4996-4998.

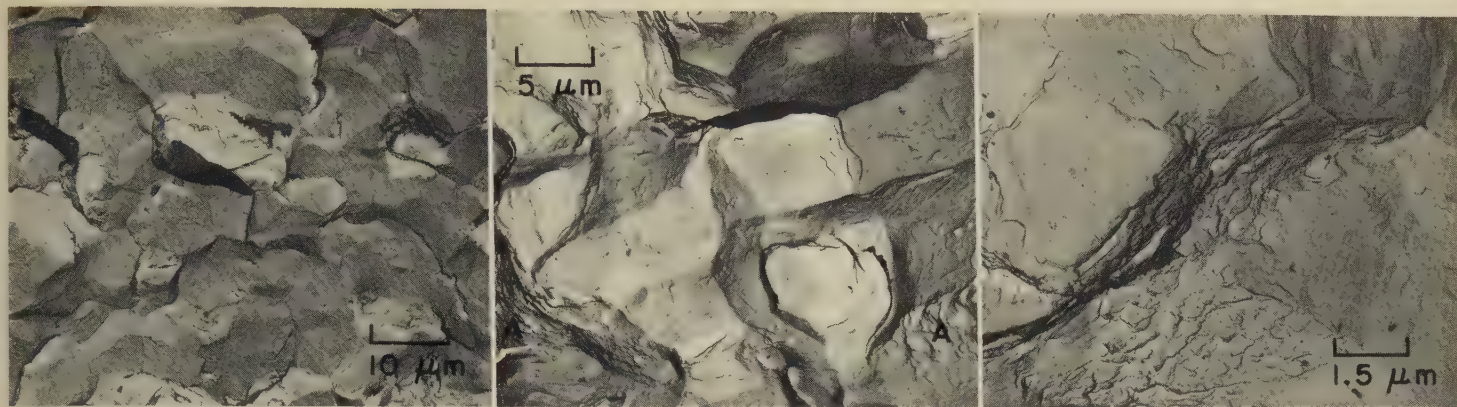
TEM fractograph (p-c replica) 1000× TEM fractograph (p-c replica) 2000× TEM fractograph (p-c replica) 6500×
4996, 4997, 4998 Fractographs 4996 (left) and 4997 (center) show surfaces of impact fractures in two specimens of hydrogen-embrittled 4340 steel (continuation of a series begun in 4992, on the opposite page). The fracture in 4996 bears a considerable resemblance to those shown in 4991 and 4992, except that fewer quasicleavage facets are visible here. The fracture in 4997 exhibits intergranular facets containing many fine tear ridges; two areas of fine dimples (at A's) are visible also. Fractograph 4998 (right) shows the surface of a fracture in a specimen of hydrogen-embrittled 4340 steel that was broken under sustained load, exhibiting intergranular facets, and dimples that resulted from microvoid coalescence.

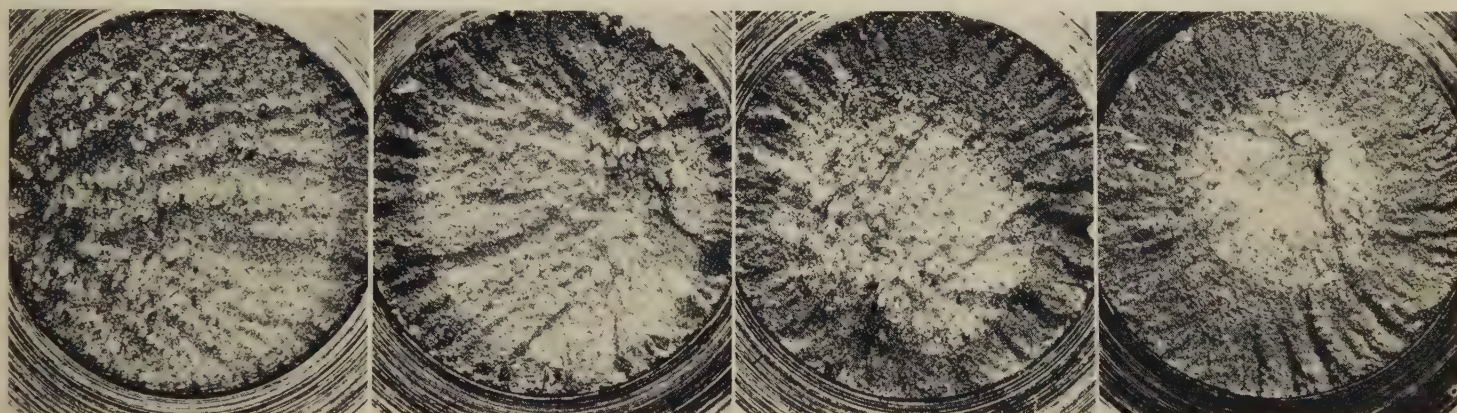
Light fractograph About 8× Light fractograph About 8× Light fractograph About 8× Light fractograph About 8×
4999, 5000, 5001, 5002 Surfaces of four tension fractures, which illustrate the effect of decreasing stress on the fracture-surface characteristics of notched specimens of 4340 steel broken at room temperature. Notch radius was 0.001 in. Microstructure of all four specimens was tempered martensite. The specimen at far left (4999) was broken by tension overload (notched tensile strength was 2006 MPa, or 291 ksi) and shows a relatively small fibrous zone at the right edge. The three other specimens were charged with hydrogen and then were subjected to sustained loading. The specimen at left center (5000) broke in 1.65 hr under a stress of 1379 MPa (200 ksi). The specimen at right center (5001) broke after 5.35 hr under a stress of 1034 MPa (150 ksi). The specimen at far right (5002) fractured after 5.5 hr under a stress of 689 MPa (100 ksi). Note that the progressive decrease in fracture stress from 4999 to 5002 was related to a progressive increase in the size of the fibrous zone.

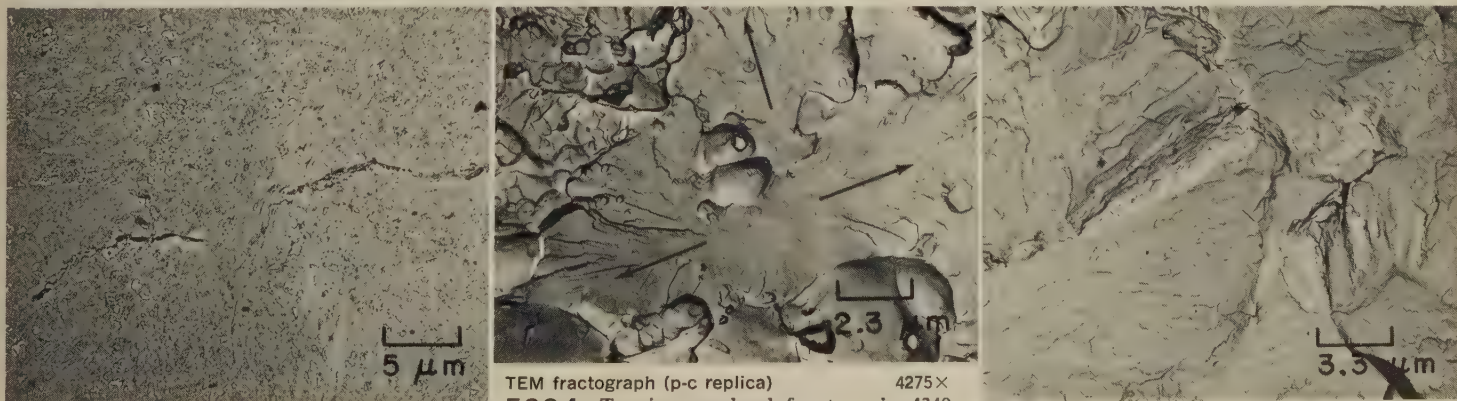
TEM micrograph (nital) 2000× TEM fractograph (p-c replica) 4275× TEM fractograph (p-c replica) 3000×
5003 A plastic-carbon TEM replica of a polished and etched section through a specimen of 4340 steel containing internal grain-boundary cracks caused by hydrogen embrittlement.
5004 Tension-overload fracture in 4340 steel notched specimen. Fracture occurred both by microvoid coalescence (see fine dimples at upper left, large dimples at lower right) and by quasicleavage through pearlite colonies (see facet at center). Arrows show directions of crack propagation.
5005 Fatigue fracture in 4340 steel that was tested in humid air, exhibiting an intergranular surface similar to one caused by stress corrosion and showing no conventional characteristics of fatigue.

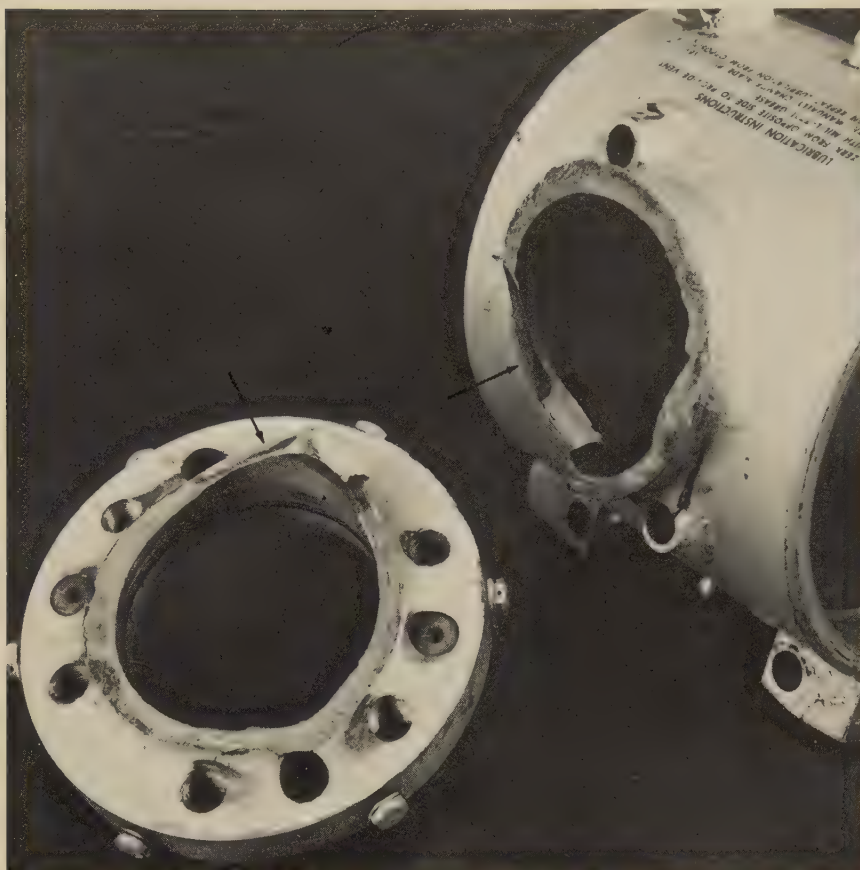
Photograph

5006 Mating segments of an aircraft propeller hub of quenched and tempered 4340 steel that broke by fatigue, showing both surfaces of the fracture, which occurred at the welded joint between the barrel of the hub and the fitting for attachment of the hub to the hydraulic cylinder. Arrows indicate on each fracture surface the location of the fatigue-crack origin—at the toe of the weld bead, where a slight weld overlap had formed. See also 5007 to 5009.

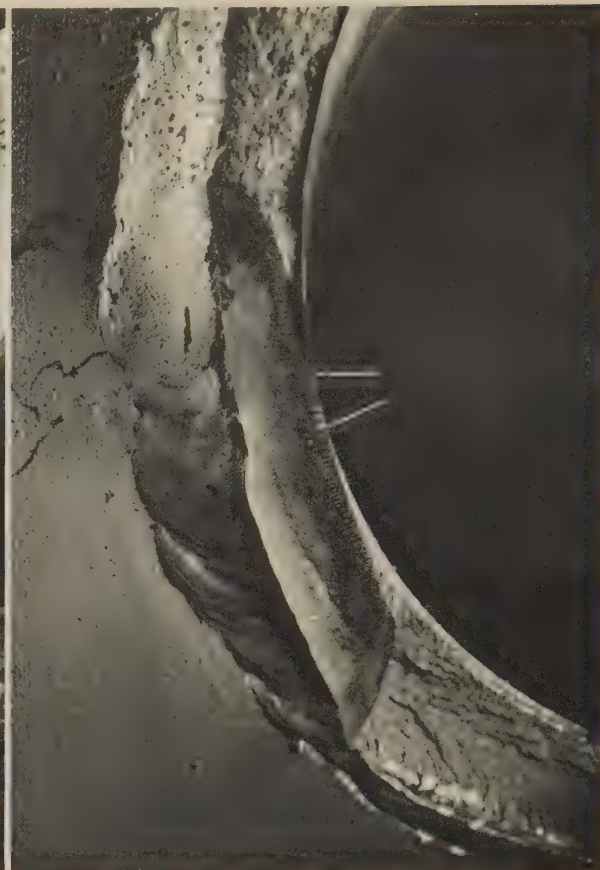
Light fractograph

5007 Fracture surface of the barrel portion of the broken hub in 5006, showing the fatigue-crack origin. The fatigue crack was about 1 3/4 in. long but had penetrated the hub wall completely for only about 1/8 in. (arrows). Note shear lip at inside of hub wall on either side of the fatigue crack.

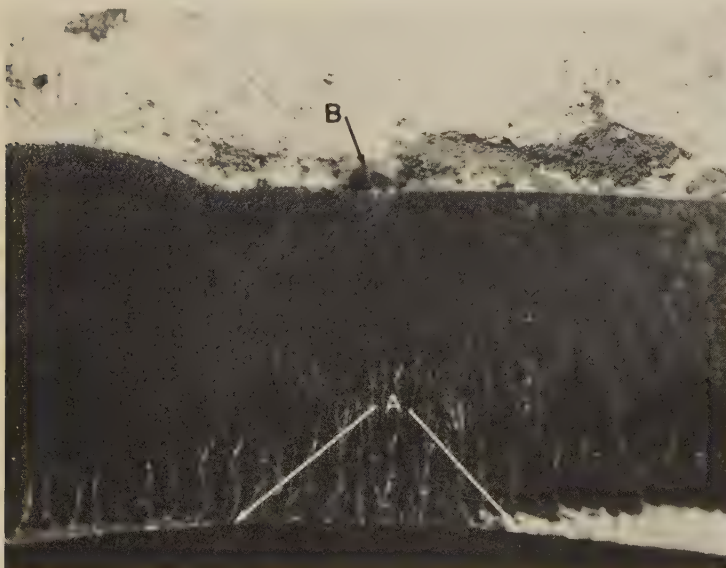
Light fractograph

5008 A higher-magnification view of the fatigue-crack origin in fractograph 5007, showing clearly the beginnings of the shear lips (arrows at A) on each side of the zone of complete penetration of the fatigue crack. At the upper edge of the fatigue crack, a small piece of protruding weld metal is visible (arrow B) at the crack nucleus.

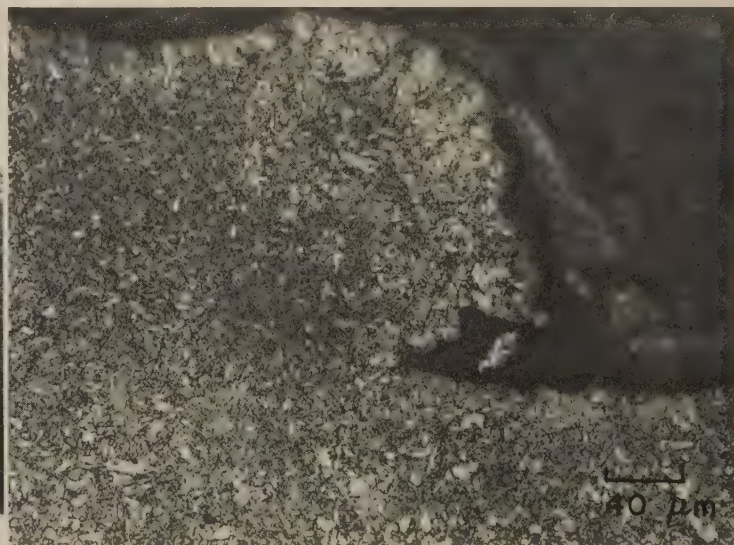
Micrograph (1% nital)

5009 Polished and etched section through the weld and base metal of the fitting portion of the broken hub in 5006, at a point near (but not at) the fracture surface, showing a weld overlap, which forms a crevice. It was at a similar crevice that the stress caused by the heat of welding opened a crack in the hub wall. Otherwise, the weld was sound and well bonded. Hardness: Rockwell C 23 to 43 in the weld; Rockwell C 35 to 44 in the base metal.

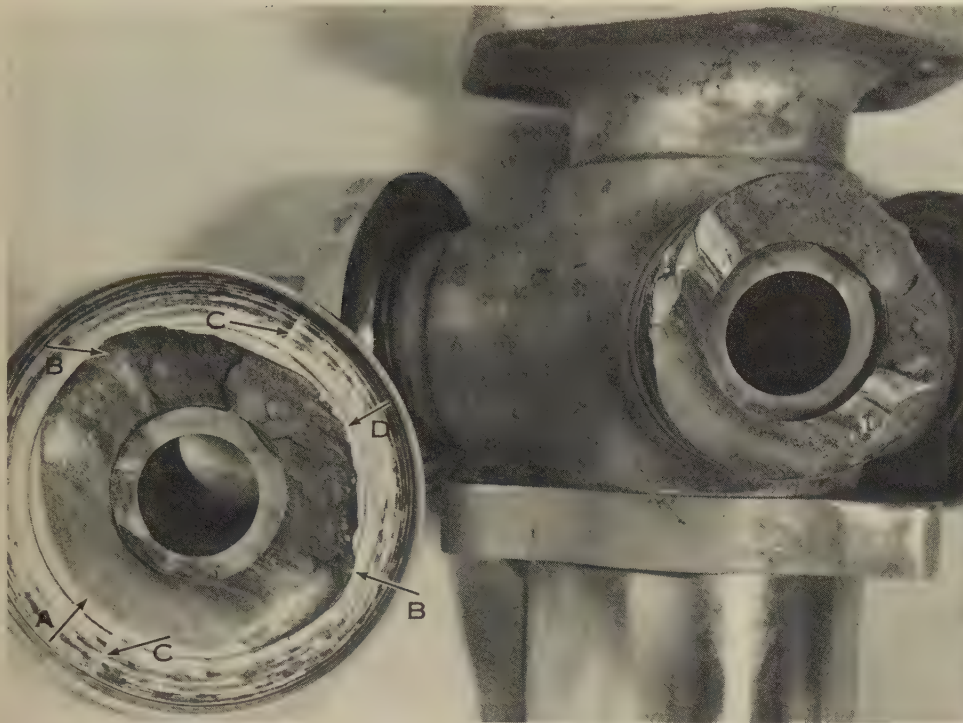
Light fractograph

5010 Mating surfaces of a fatigue fracture in a blade arm of a forged aircraft propeller-hub spider of 4340 steel and through the central pilot tube of the arm. The fatigue crack originated in the fillet between the bearing-retention flange and the blade arm. Hardness of the forging was Rockwell C 35. The origin is at arrow A (lower left), at an inclusion. The fatigue crack penetrated as far as the locations indicated by arrows B before final, fast fracture occurred. Alignment of the bearing-race parting line (arrows C) was not as specified. See fractograph 5011, at right, for a view at arrow D.

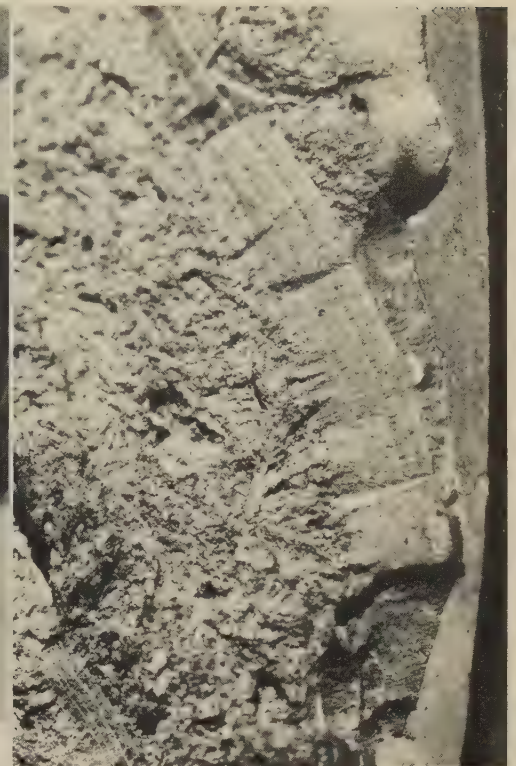
Light fractograph

5011 A view of an area at arrow D in 5010, in the region of final, fast fracture. Fatigue patches are interspersed among areas of rapid crack advance, indicating that final fracture occurred in stages.

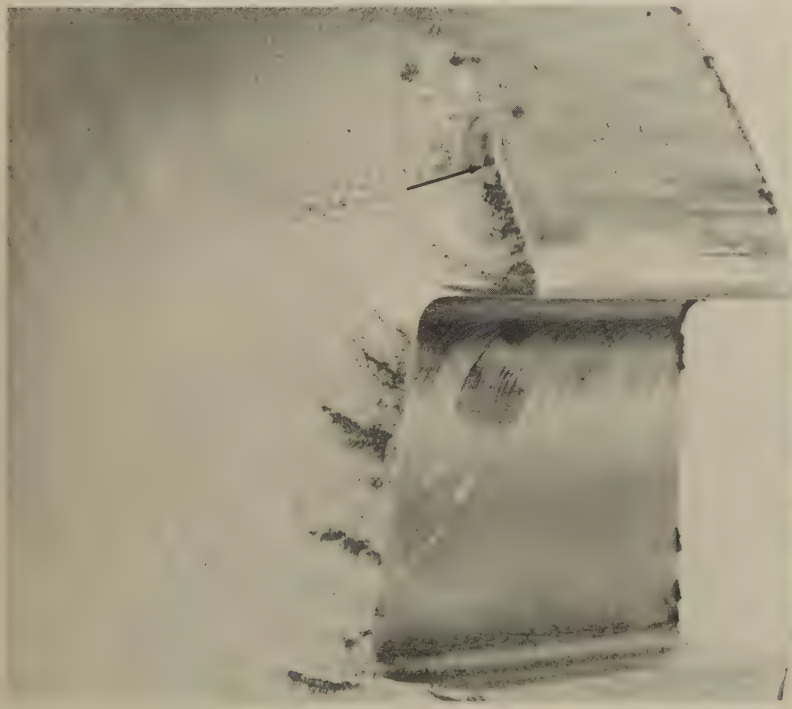
Light fractograph

5012 Surface of a fatigue fracture in the worm-gear shaft of a 400-ton open-hearth stripper crane, which broke after 18 months of service. The material was 4340 steel heat treated to a hardness of 280 Bhn. The fatigue-crack origin is visible at the arrow at upper right, above the keyway, in an area that had been grooved and abraded when the worm gear was pressed onto the shaft. See also 5013.

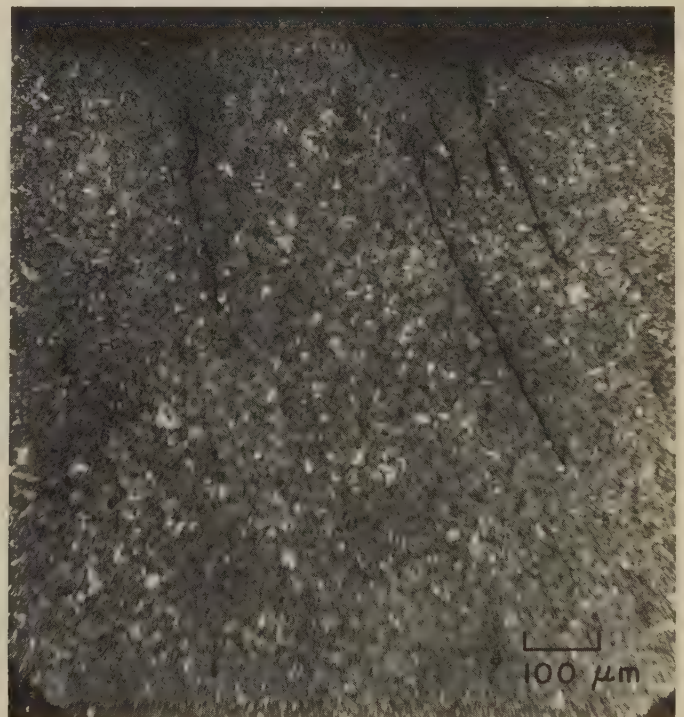
Micrograph (nital)

5013 Polished and etched section taken longitudinally through the broken worm-gear shaft in 5012, adjacent to the fracture surface, showing transverse cracks that originated at the heavily cold worked surface of the shaft (at top). A similar crack initiated the fatigue fracture.

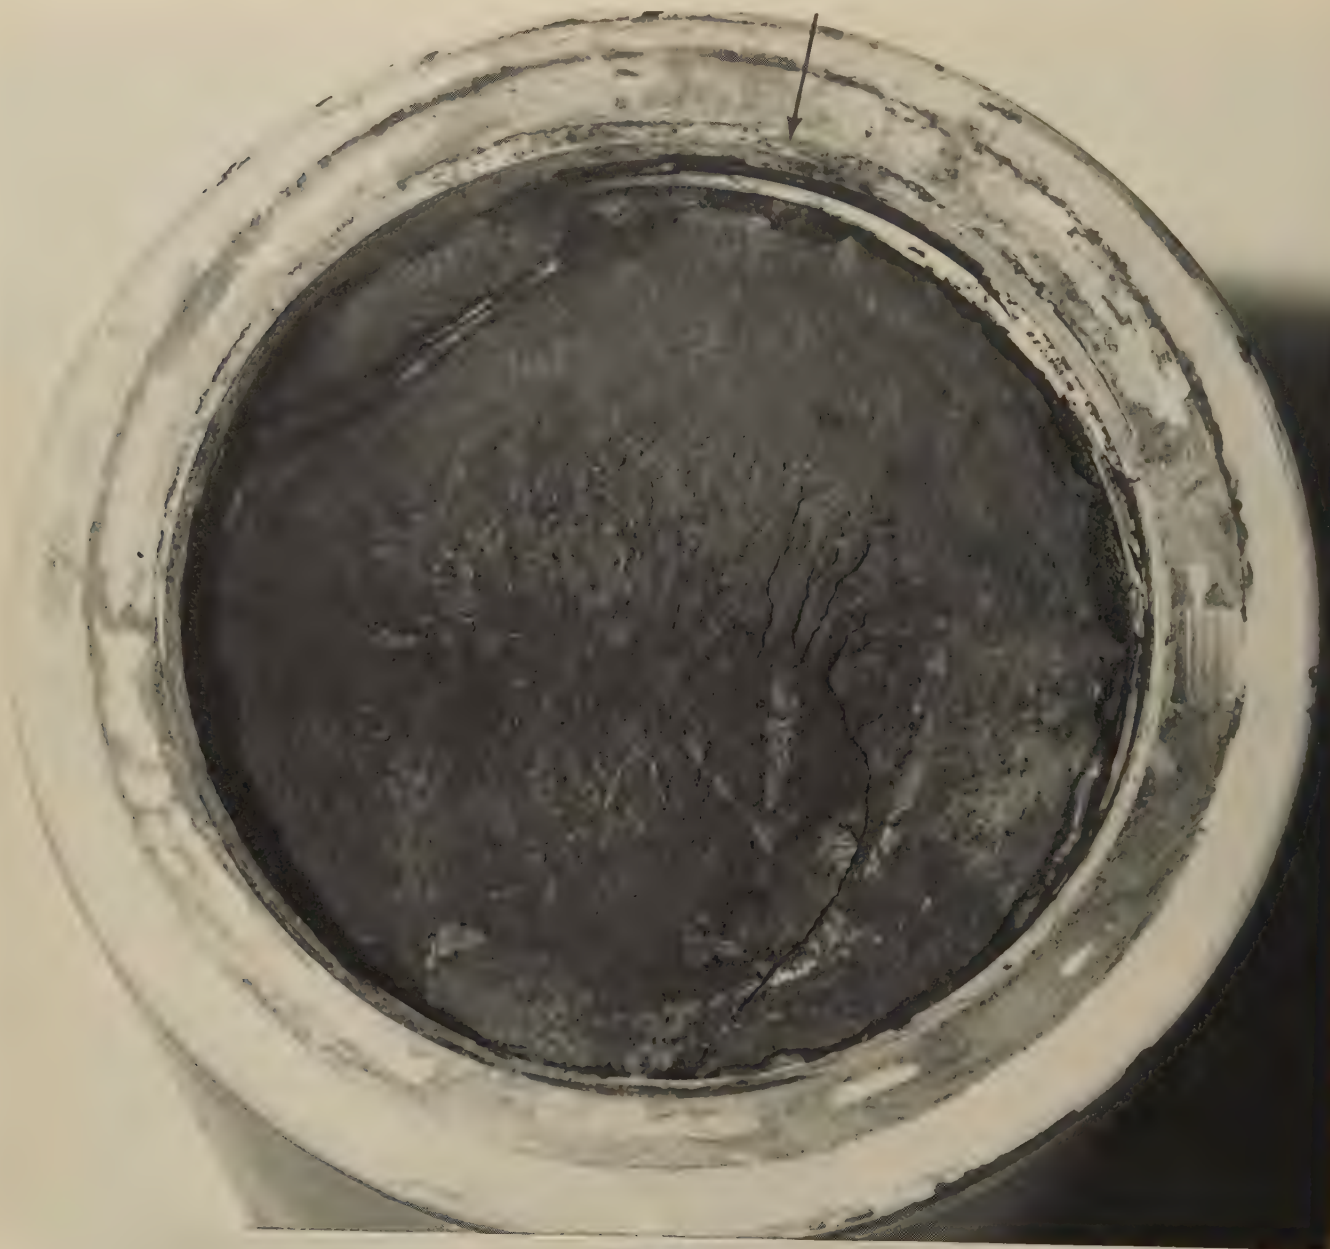
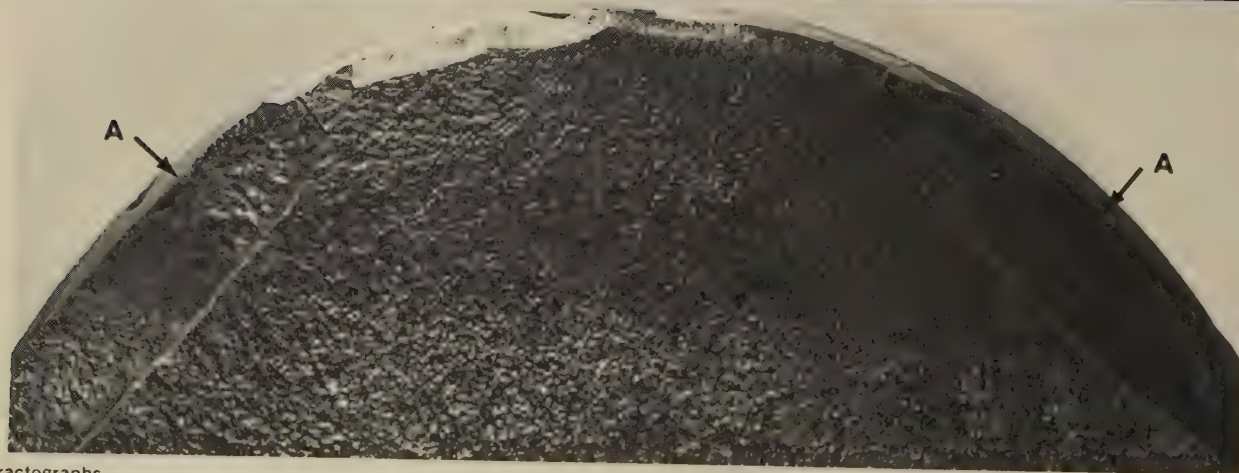
Two light fractographs

5014, 5015 At top (5014) is a view of a service fracture in a 5-in.-diam suspension strut of a missile silo. Actual size (5014); $1\frac{1}{2} \times$ (5015) treated to tensile strength of 1612.7 MPa (233.9 ksi), 11% elongation, and Charpy V-notch impact strength of 17.3 joules (12.8 ft-lb). The fracture origin (arrow) is at a thread root, two full threads deep into the coupling. At bottom (5015) is a view of the origin in the mating fracture surface (shown in 5016, on facing page). Note that two wedge-shaped pieces had been broken from the strut perimeter at symmetrical locations on either side of the origin (arrows A); one remained in the coupling and is visible in 5014.

5016, 5017 At top (5016) is the mating fracture surface of the strut in 5014 (facing page). The fracture (origin at arrow) penetrated the strut at an angle, starting at the second thread within the coupling and emerging six threads lower on the opposite side. In both fracture surfaces, in the area opposite the origin, is a crudely circular crater with shear-lip borders. At bottom (5017) is a view of the threads near the origin. Note that the thread behind the fracture surface is partly stripped and there are corrosion pits on the threads. Fracture was ascribed to thread defects, corrosion, and excessive strength with low toughness.

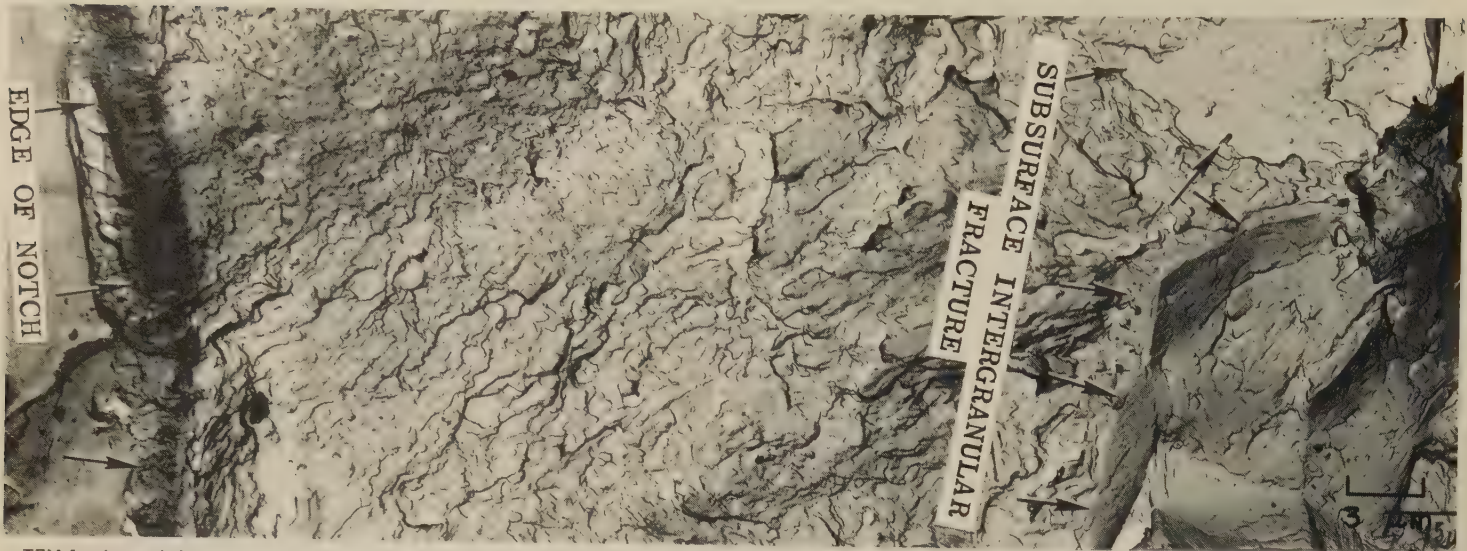
TEM fractograph (p-c replica)

5018 Surface of an intergranular fracture in a hydrogen-embrittled notched specimen of 300M steel. The specimen was hydrogen embrittled during cadmium plating in a cyanide bath after being heat treated to a tensile strength in the range of 1862 to 2068 MPa (270 to 300 ksi); fracture occurred during testing at a sustained stress of 858 MPa (124.5 ksi). It has been observed in hydrogen-embrittled steels that when a sharp notch is present, nucleation of intergranular fracture occurs close to the notch, and when an extremely sharp notch (such as a heat-treat crack) is present, intergranular fracture occurs as a continuous extension of that notch. Here, where the notch was relatively blunt (0.005-in. radius), the fracture had a subsurface origin.

3300×

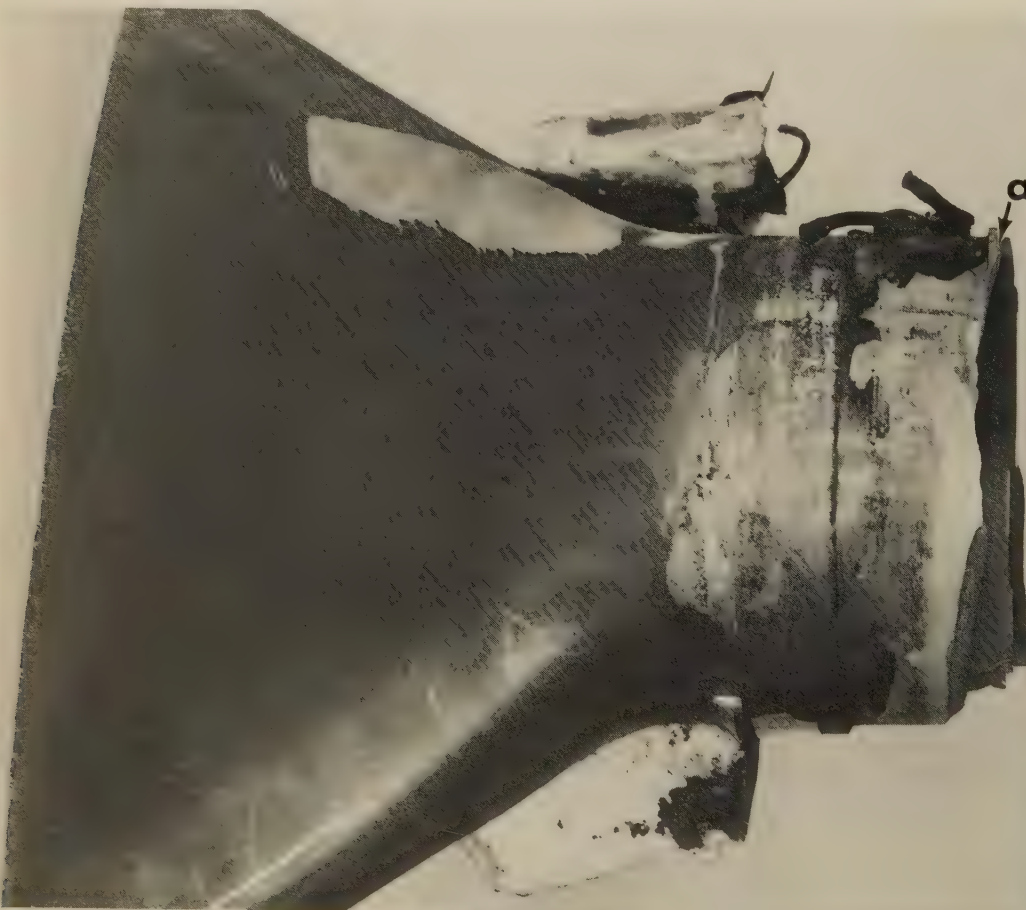
Photograph

5019 A portion of an aircraft propeller blade of 4350 steel that fractured in fatigue after about 1250 hr of service. The fracture occurred in the root section of the blade; the location of the origin is indicated by arrow "a", in the fillet at the inboard side of the cuff ring. The fracture was initiated by a crack that had been oxidized by exposure to air while the steel was at high temperature (as, for example, in forging or in heat treatment without atmosphere control). See also 5020 through 5024 (at right, and on the opposite page).

5020 View of the fatigue-crack origin at arrow "a" in 5019, visible here at the right edge of the dark, oxide-covered granular crack indicated by arrows marked "c".

5021 View of the surface of the propeller-blade fatigue fracture in 5019 (facing page). The dark, oxidized surface of the crack that initiated the fatigue fracture is at "a" (top right). The fatigue crack penetrated the blade wall at "a" and then progressed in both directions along the wall to the points marked "b" before final, fast fracture took place. The extremely fine beach marks visible here and in 5020 are typical of very high-cycle fatigue.

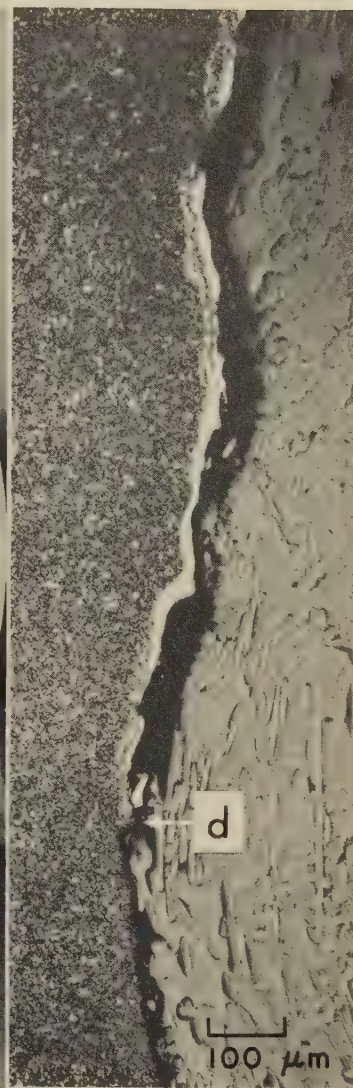
5022 Polished and etched section through fracture origin in 5019, showing oxide layer (light) on initial crack above "d", fatigue crack below "d", blade metal at left.

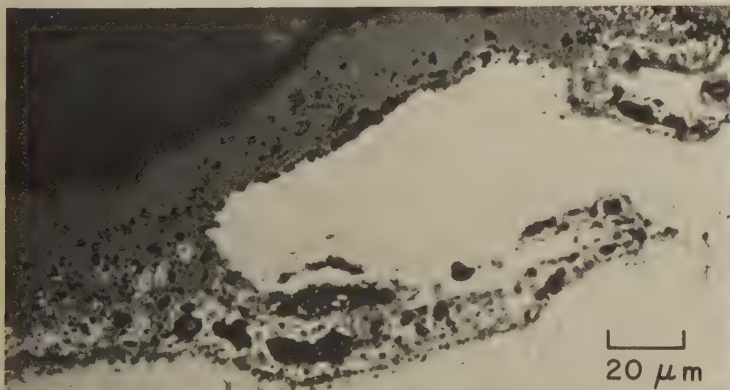
5023 A polished but unetched section through the fracture-initiating crack in 5019, showing an oxide layer, which penetrated the blade metal (light gray areas) at a few locations. Dark surface at top left is the specimen-mounting material.

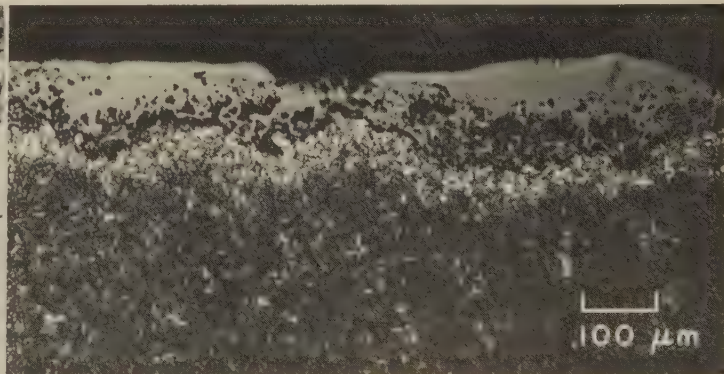
5024 A polished and etched section through the fracture-initiating crack in 5019, showing the microstructure of the blade metal. Note the shallow zone of decarburization below the oxide layer; both the decarburization and the oxide were caused by high-temperature exposure to air.

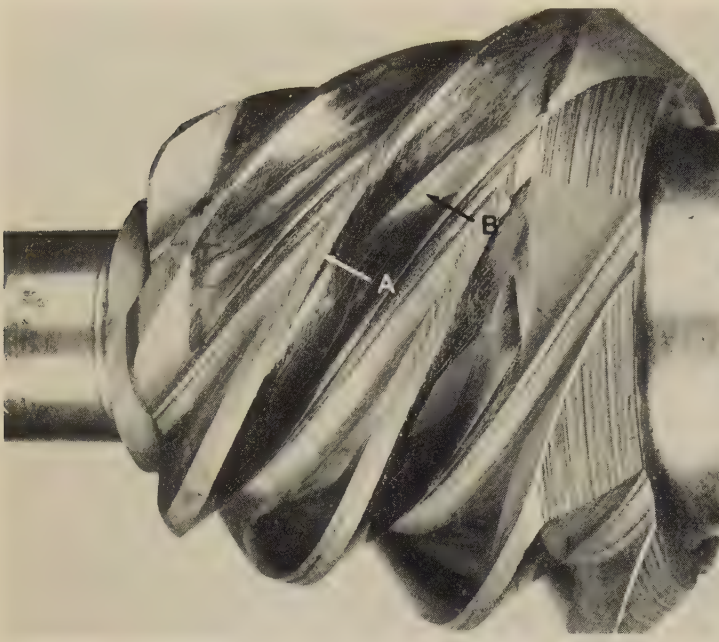
Photograph
5025 View of a carburized spiral gear of 4817 steel, showing fine subcase fatigue cracks in the gear-tooth tips (such as at arrow A) and flanks (such as at arrow B); these cracks are evidence of the first stages of spalling fatigue, which originated near the case-core interface because the load-carrying capacity of the gear was exceeded. Compare with photograph 5026 (at right).

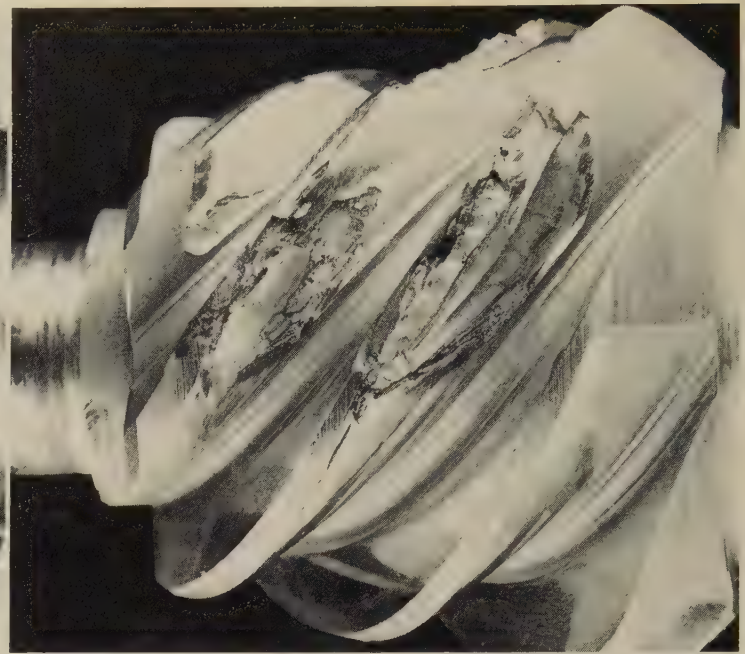
Photograph
5026 A companion gear to that in 5025, also of 4817 steel and carburized, showing subcase fatigue fractures initiated by fine cracks similar to those in 5025. Note that large fragments have spalled away from the teeth. Fatigue beach marks can be seen in these complex fracture surfaces, especially at upper right.

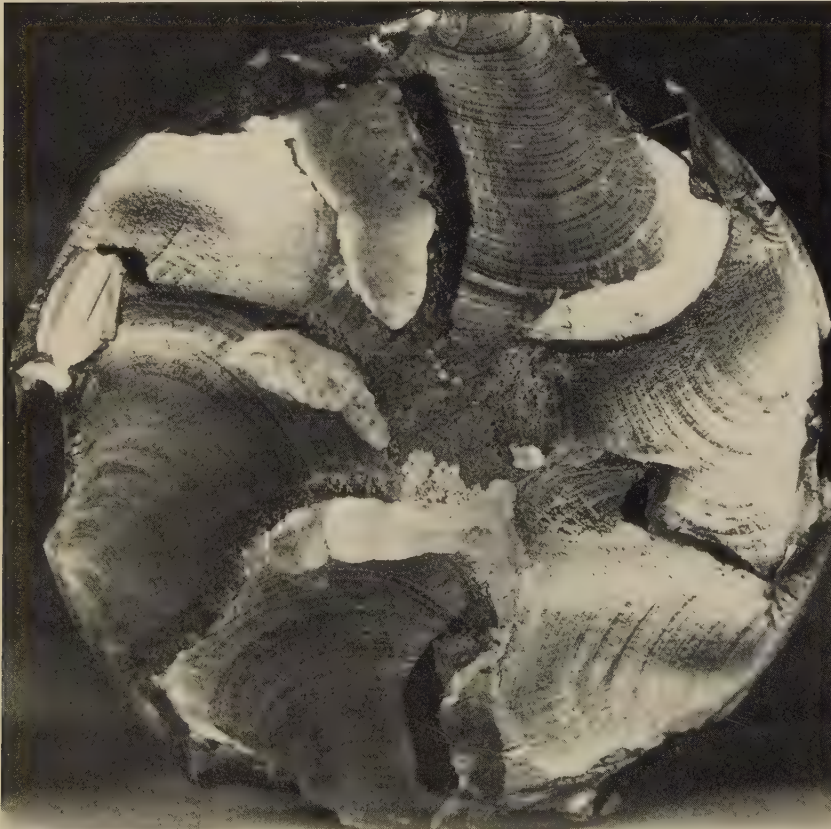
Light fractograph
5027 Surface of a fatigue fracture that began at six fillet areas around the periphery of a shaft, near the runouts of spiral grooves. The material is 4817 steel; the shaft was carburized and heat treated to a surface hardness of Rockwell C 60. The fatigue cracks penetrated equally, indicating that stress concentrations at the six fillet areas were essentially equal.

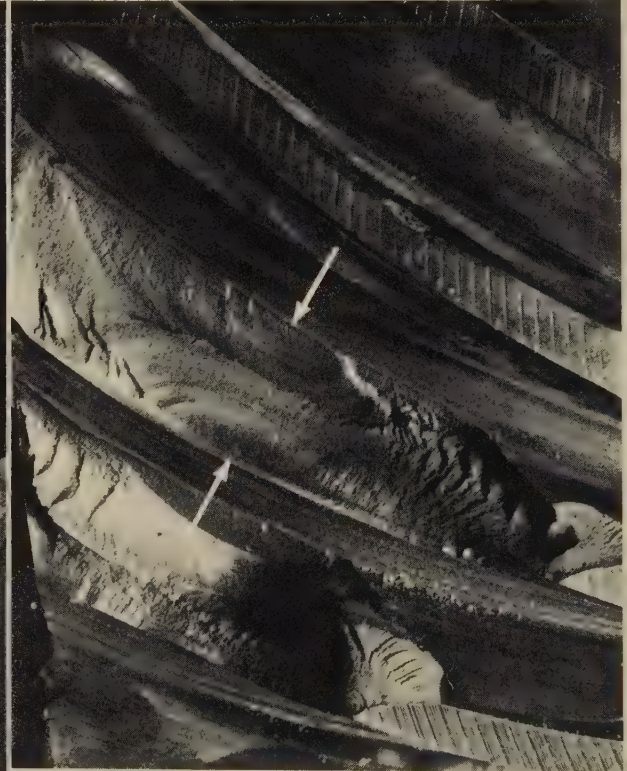
Light fractograph
5028 Fatigue fractures in a spiral bevel pinion gear of 4820H steel, case hardened to a depth of 0.045 to 0.080 in. Case hardness, Rockwell C 56; core hardness, Rockwell C 30. Fatigue cracks began in tooth roots (which were not shot peened), often forming on either side of a tooth (arrows) and meeting in the middle of the tooth. A deeper case, and shot peening of the entire gear, were recommended.

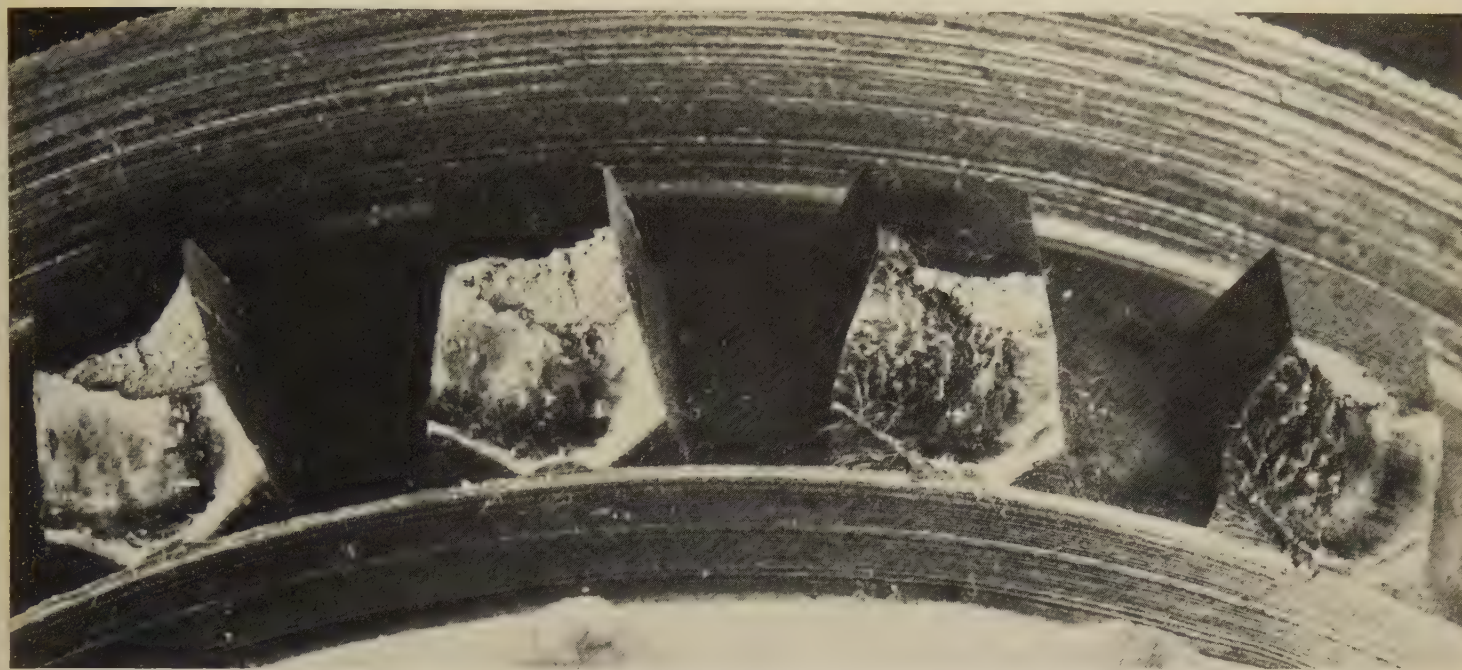
5029 Fractures in teeth of a carburized gear of 50B20 steel, heat treated to a surface hardness of Rockwell C 60, and subjected to 10,000 impact blows, which chipped and battered the corners of the teeth as shown here. Repeated blows subsequent to fracturing have obscured many of the fracture-surface characteristics in the two teeth at right. In the two teeth at left, large fragments were removed late in the test, exposing fracture surfaces that were generally untouched by subsequent battering.

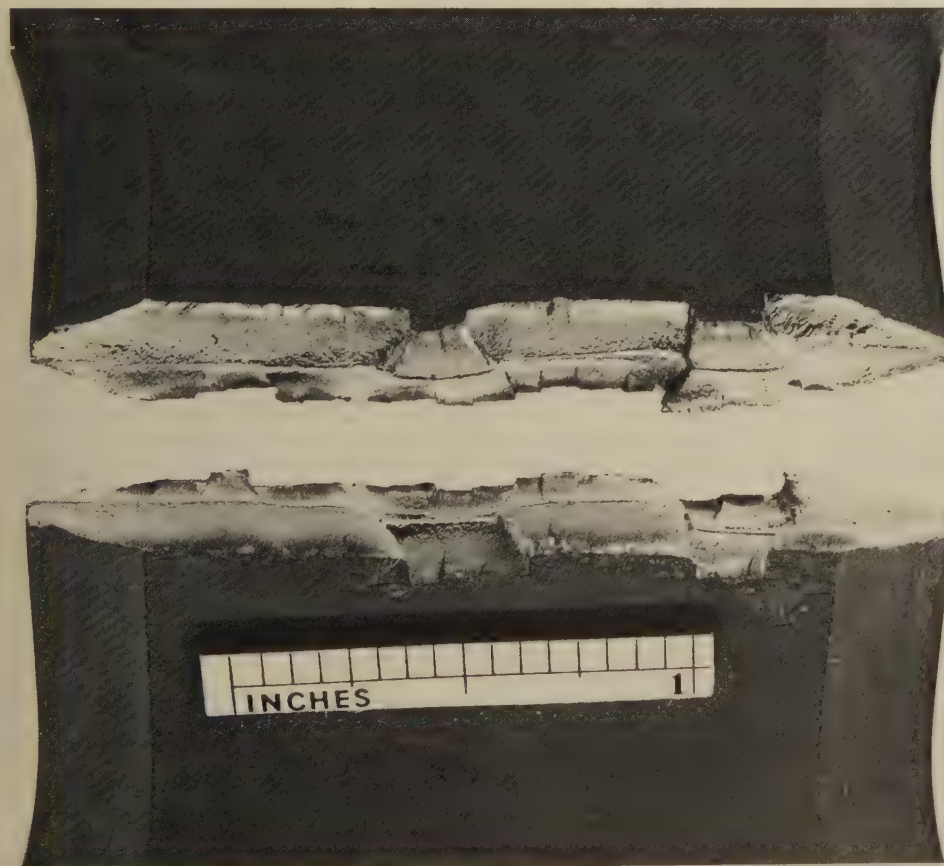
5030 Oblique view of the mating surfaces of a fatigue fracture produced in reversed bending in a 1/4-in.-thick specimen of high-strength low-alloy steel plate with a yield strength of about 345 MPa (about 50 ksi). Multiple fatigue cracks originated at both surfaces of the specimen. Note the centerline neutral axis.

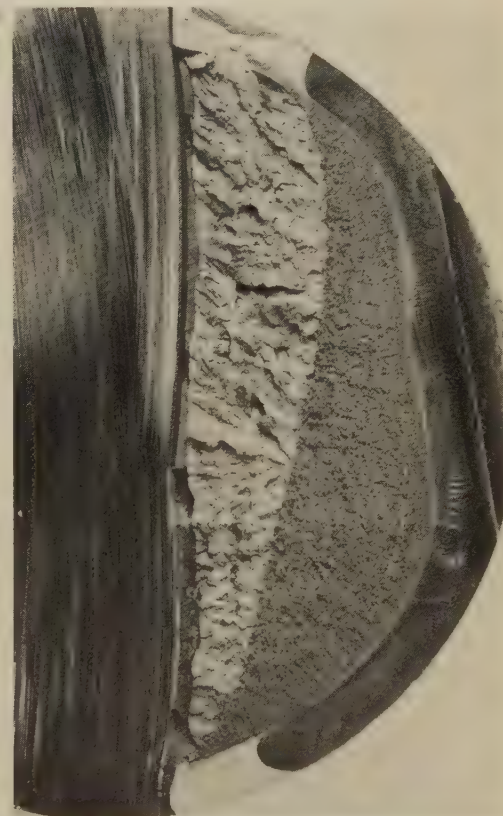
5031 Case-hardened pin of 5046 steel with a hardness of Rockwell C 61 in the case, 248 Bhn in the core, showing fatigue zone (right). The pin was cut (at left), then broken (light area at center). Sectioning of the pin revealed subcase fatigue cracking.

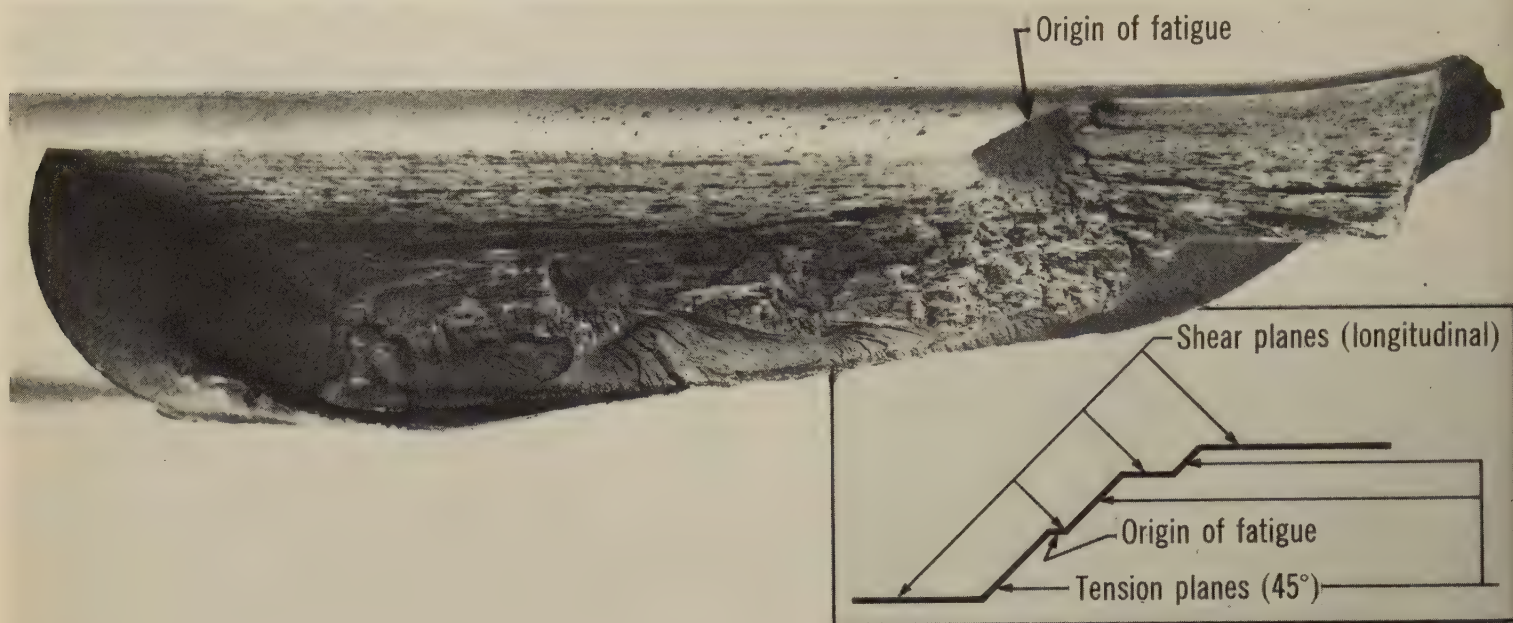
5032 Surface of a torsional-fatigue fracture in the cylindrical portion of a 1½-in.-diam torsion-bar spring of 50B60 steel heat treated to a hardness of Rockwell C 53. The fatigue crack originated in a very small (0.015 in. long) facet (labeled "Origin of fatigue") on a longitudinal shear plane and progressed alternately on 45° tension planes and longitudinal shear planes, as indicated in the diagram. Note that the semicircular fatigue patch surrounding the origin lies in the 45° plane.

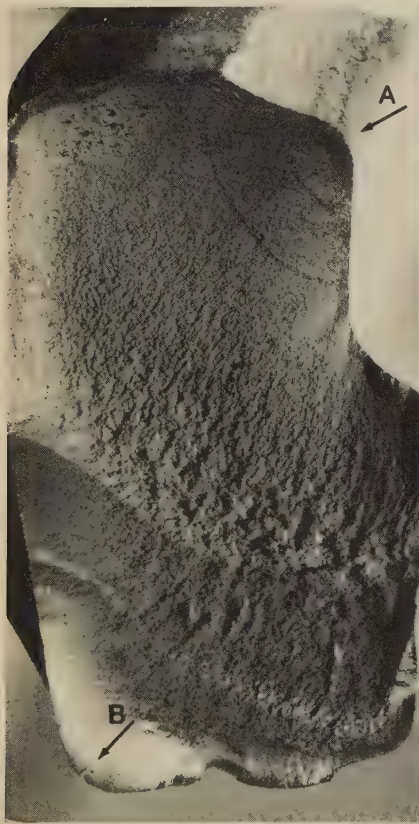
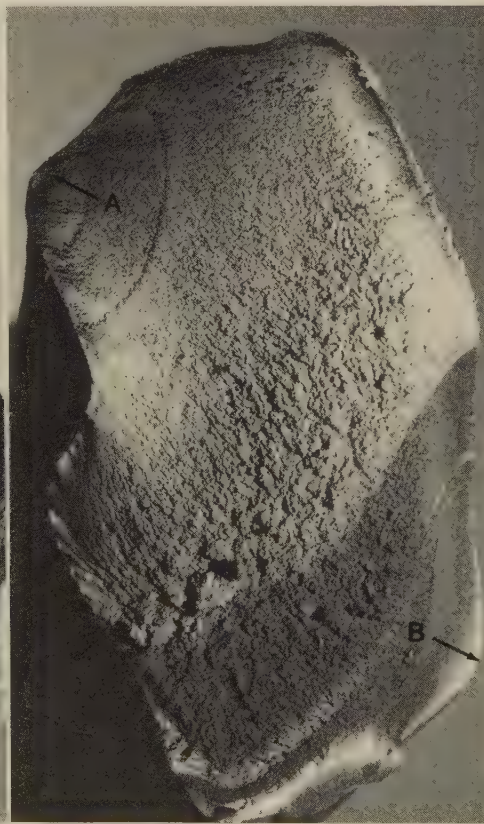
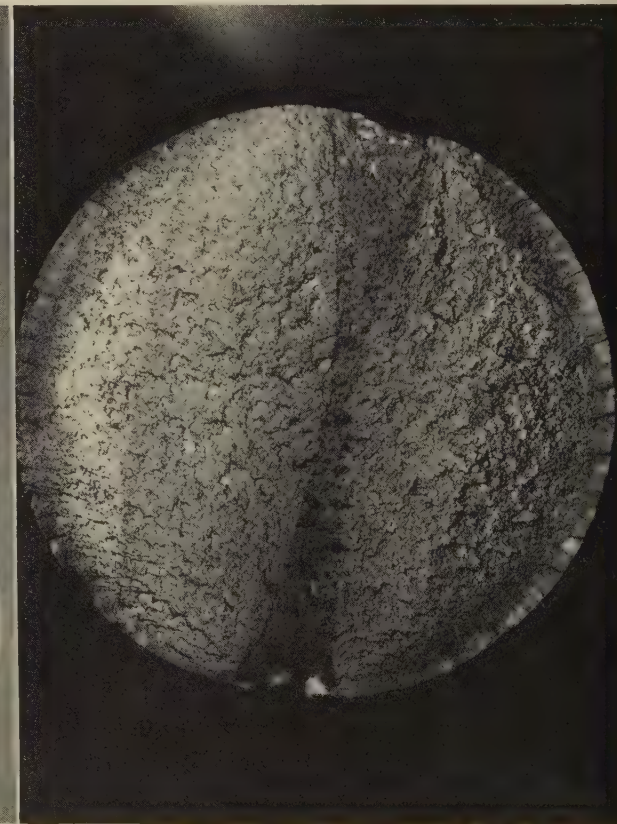
5033, 5034

Views of the mating fracture surfaces of a suspension component that was fabricated of 5132 steel and that broke in a fatigue test. Note the two fatigue-crack origins, one at arrows A (top) and the other at arrows B (bottom). The crack that was initiated at the origin at arrows B is the earlier crack, as indicated by the well-rubbed surface near that origin.

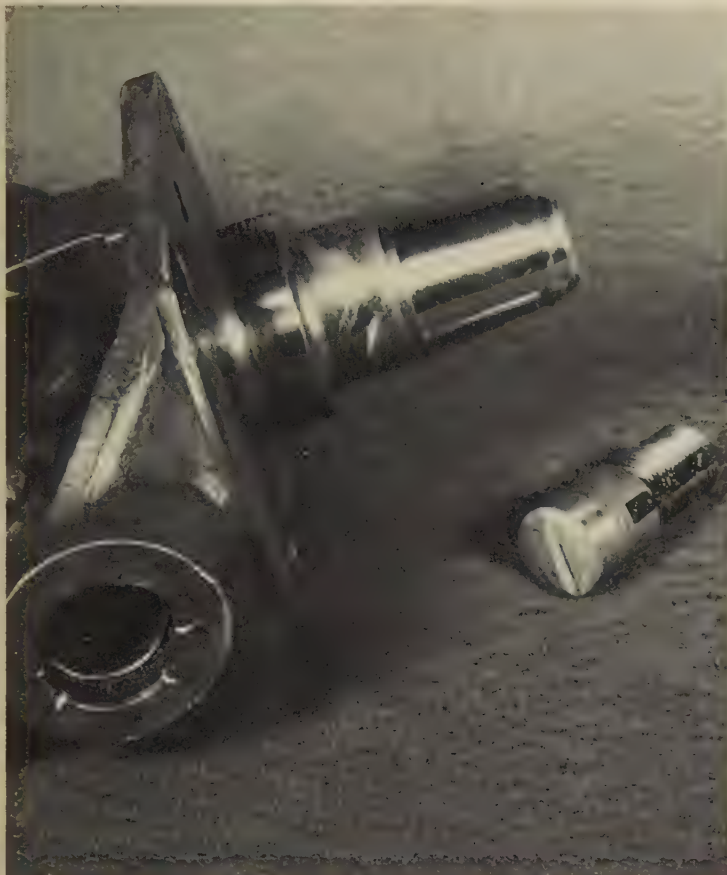
Photograph 3/4×
5036 Fracture in the spindle of a steering knuckle fabricated of 5135H steel and heat treated to a uniform hardness of Rockwell C 29. Fracture was caused by fatigue cracks that formed on opposite sides of the spindle, at the root of a fillet in the straight section adjacent to the threads. See also 5037 to 5039.
